## Overview of plasma-tungsten surfaces interactions on the divertor test sector in WEST during the C3 and C4 campaigns

M. Diez, M. Balden, S. Brezinsek, Y. Corre, N. Fedorczak, et al.. Overview of plasma-tungsten surfaces interactions on the divertor test sector in WEST during the C3 and C4 campaigns. Nuclear Materials and Energy, 2023, 34, pp.101399. 10.1016/j.nme.2023.101399 . hal-04396242

Studying the ageing of tungsten monoblocks, their erosion and their fuel inventory is the priority of the WEST post-mortem analyses programme. Actively-cooled ITER-like plasma-facing units (PFUs) and special W-coated marker lower divertor tiles were retrieved from the WEST divertor after the C3 and C4 experimental campaigns to perform ex-situ analyses. The erosion/deposition pattern on the divertor was determined. The deposition is found mainly on the inner side which is covered by layered deposits that increase in thickness in the radial direction from a few hundreds of nm to a maximum of  $>10\ \mu\text{m}$ . The deposits are mainly composed of W, O, C, B and D coming from transport of W in the vacuum chamber, oxidized layers and boronizations. Traces of Cu, Fe, Mo, Cr, Ag were also detect

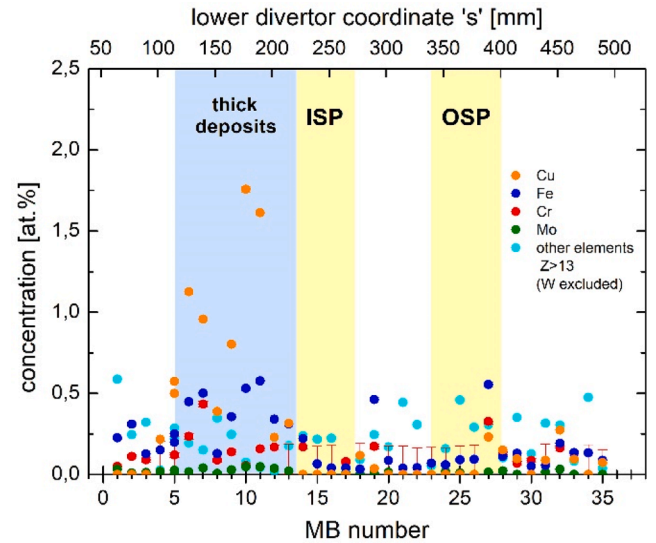
Fig. 8. Main impurities content measured by xrf along the radial direction of iter-like pfu ilp2 after exposure to c1–c4.

The surface composition of the divertor targets along the radial direction was measured by X-ray fluorescence (XRF). Measurements were made at the centre of each monoblock on ILP2 after exposure to C1-C4, using Olympus Vanta's system with a rhodium X-ray tube, a high voltage of 40 kV and a collimator of 10 mm diameter. With this technique, only elements with  $Z > 13$  are detected. Therefore, the composition of deposits given by XRF presented in Fig. 8 does not include light elements such as B, O, C or D.

The results indicate that the main high Z impurities on the PFU's surface are Cu (LH antennas), Fe and Cr (stainless steel panels) as well as Mo (interlayer coating in the lower divertor graphite tiles). They are mainly found in the region of thick deposits, with a content reaching up to 2 at.%. A non-exposed W sample provided by the same manufacturer than ILP2 was used as a reference and did not reveal the presence of Cu, Fe, Cr and Mo. Therefore, these results clearly evidence that heavy impurities from the main chamber were transported and redeposited in the HFS of the divertor. Ta, Ti and V were also detected on the ITER-like PFU surface with a concentration of about 0.25–0.5 at.% ('other elements with  $Z > 13$ ' in the figure. This does not include W) but their homogeneous repartition along the divertor suggest a different transport mode or origin. For comparison, the value of the reference sample for elements  $Z > 13$  was 0.17 at.%.
